Role of ultrasound and MRI in the evaluation of postoperative rotator cuff

Amit Kumar Sahu¹, Erin Kathleen Moran², Girish Gandikota²

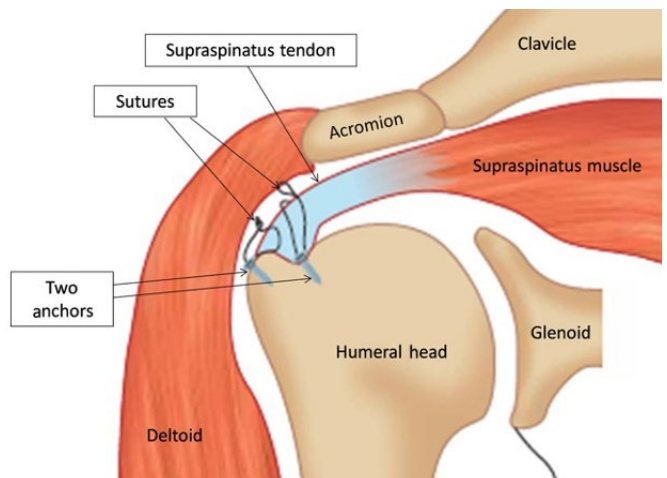
Fig. 4. Illustration demonstrating the double-row technique of rotator cuff repair

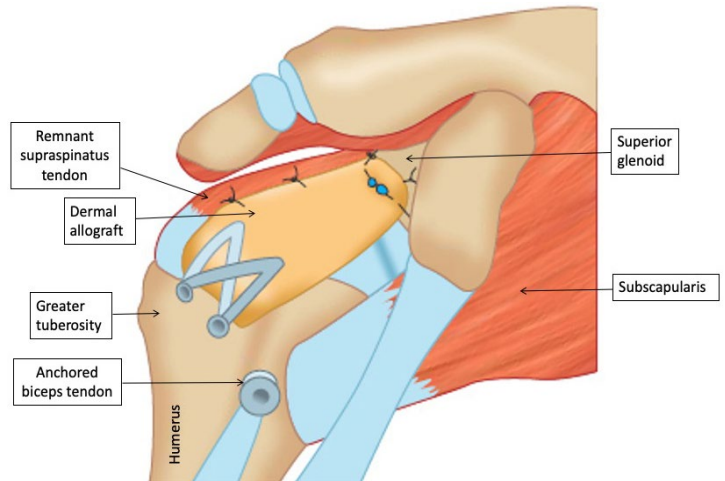
Fig. 9. Illustration demonstrating superior capsular repair with dermal allograft which is anchored with the superior glenoid, greater tuberosity, and remnant supraspinatus tendon

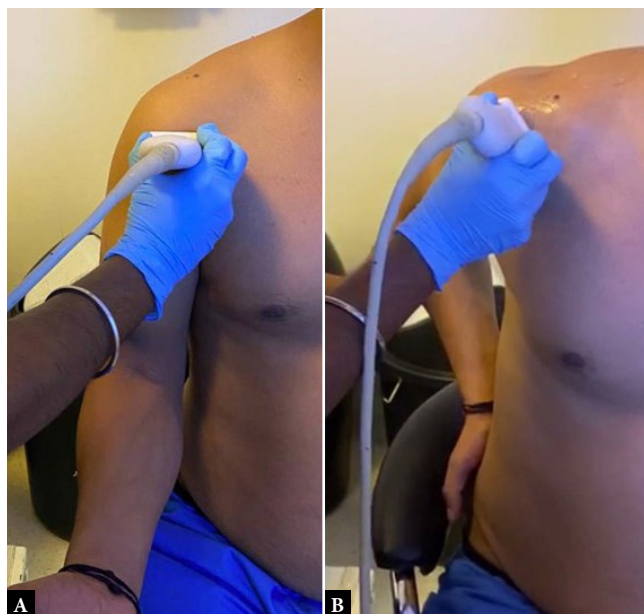
Fig. 11. US technique for rotator cuff evaluation. (A.) Patient is seated, with the elbow flexed and the arm abducted to 90 degrees (B.) Modified Crass position to evaluate supraspinatus tendon

- The patient is seated, with the elbow flexed and the arm abducted to 90 degrees. The supraspinatus tendon is evaluated in either Crass or modified Crass positions (Fig. 11). Based on the position being scanned, the torn tendon morphology can differ, with more separation of the tear in the modified Crass position (Fig. 12).
- The thickness, echogenicity, and continuity of the tendons are assessed. The supraspinatus tendon is the one that is typically repaired; thus, even though other tendons are evaluated as part of the examination, this is the one that is given the most attention. The volume of the rotator cuff muscles is also evaluated.

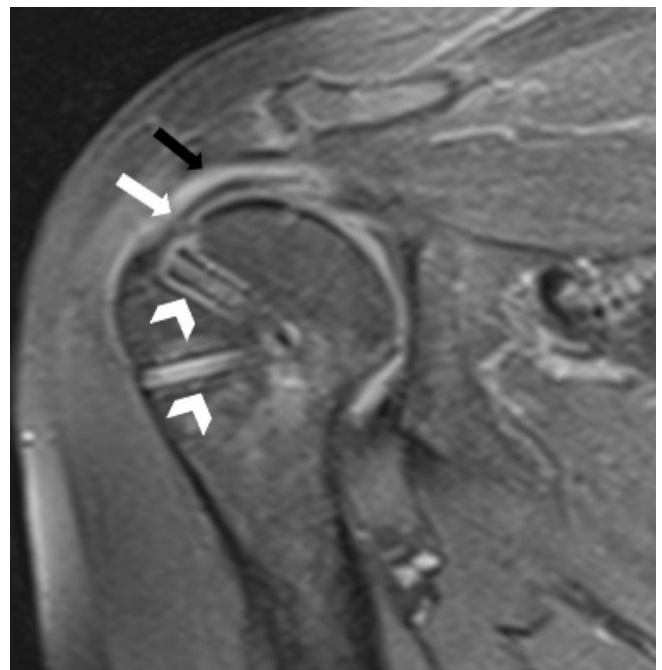
Fig. 14. Proton density fat-suppressed coronal MR image shows thinned but intact postoperative supraspinatus tendon (white arrow). There is fluid in subacromial-subdeltoid bursa (black arrow). The tendon-bone interface also appears intact. Note the presence of double-row anchors in the humeral head (arrowheads)

The subacromial-subdeltoid bursa may be thickened following rotator cuff repair (Fig. 14), which is thought to be caused by inflammation and scar tissue production. Sometimes the bursa is excised, which can lead to the pooling of fluid in its place, in the immediate postoperative period.

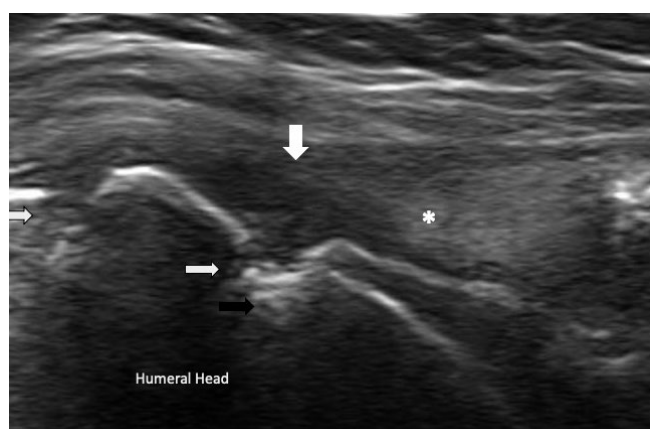
Fig. 17. Long-axis grayscale US image of repaired supraspinatus tendon shows a full-thickness re-tear with defect and exposed trough (thick white arrow). Positions of the anchors of double bundle repair could be noted in the humeral head (thin white arrows). Note the retracted tendon stump (asterisk)

- Thickening, irregularity, defect, or gap within the rotator cuff tendon (Fig. 17, Fig. 18)
- Empty trough (site of tendon attachment at the greater tuberosity) (Fig. 19)

- **Tendon thinning or retraction:** Re-tearing may result in additional tendon thinning or retraction compared to the first repair. The previously healed part of the tendon may thin out or retract, indicating that either the initial repair failed or new tendon fibers were torn (Fig. 17).

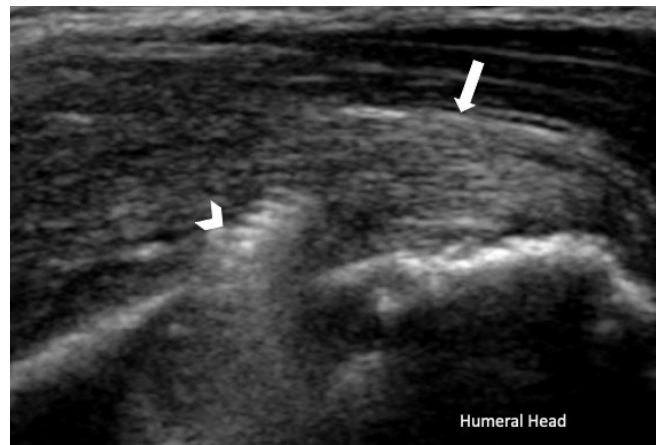
Fig. 20. Long-axis grayscale US image of repaired supraspinatus tendon (arrow) shows a protruding suture anchor (arrowhead) but intact tendon

- Recurrent tears tend to get larger and significant
- Completely or partially avulsed or dislodged suture anchor (Fig. 20)
- Fluid or other abnormalities in the subacromial space (Fig. 18)
- Biceps tendinosis

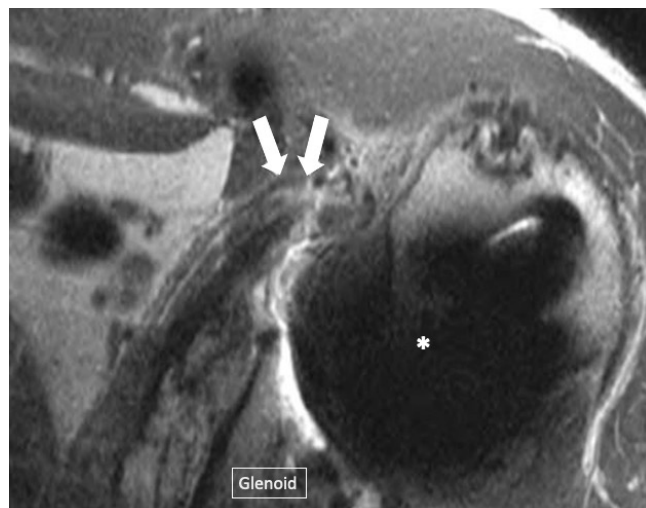
Fig. 25. Axial T2 MR image demonstrating tear of subscapularis tendon (arrows) eight months after shoulder arthroplasty. Asterisk denotes the implant in the humerus
