## Mistakes in ultrasound diagnosis of superficial lymph nodes

Ewa J. Białek<sup>1</sup>, Wiesław Jakubowski<sup>2</sup>

<sup>1</sup> Department of Diagnostic Ultrasound, Masovian Bródnowski Hospital, Warsaw, Poland

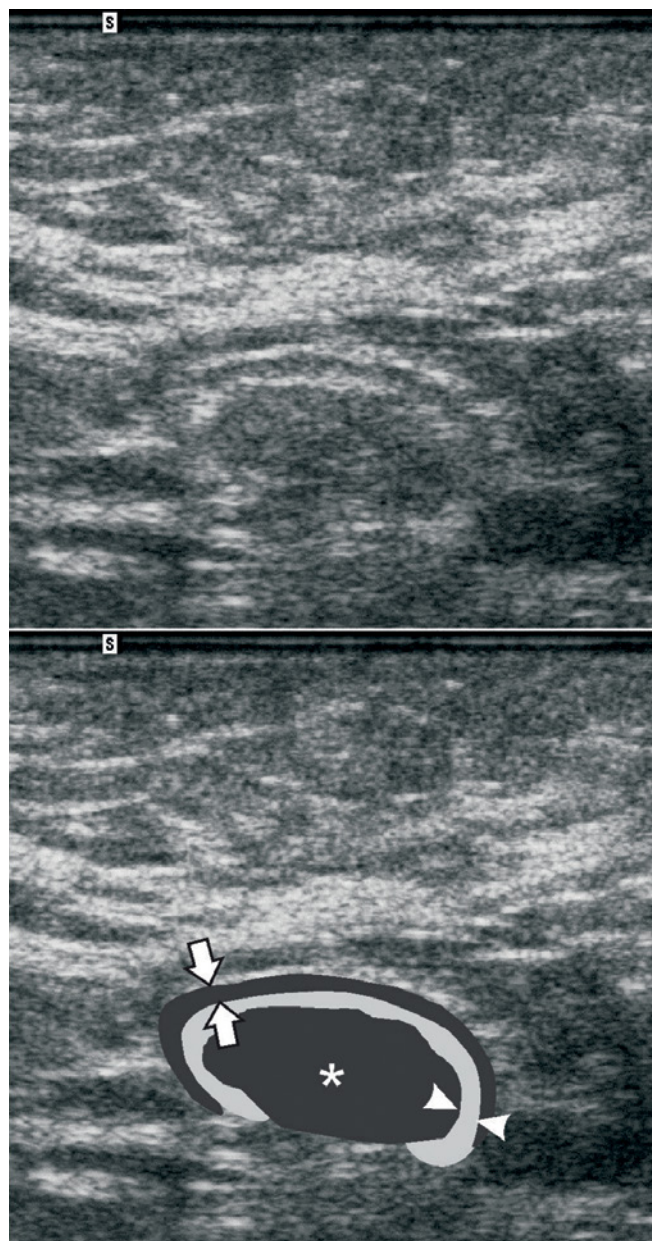
**Fig. 1.** An axillary lymph node. The thin parenchymal layer is hypoechoic (arrows) and is followed by another, internal hyperechoic layer, which represents translocated connective tissue of the hilum along with blood and lymphatic vessels (arrowheads). An extensive hypoechoic area representing homogeneous fat cells with a relatively small number of vessels (arrow) is visualized centrally. The image should not be confused with a focal thickening of the parenchymal layer, which can occur in metastases and requires US guided FNAB.

The knowledge on the details of histological and ultrasonographic correlation of normal lymph node structure increases diagnostic accuracy and the value of ultrasound. For example, axillary lymph nodes may present a specific picture due to hilar steatosis (Fig. 1). Apart from the hypoechoic crescent-shaped parenchymal layer followed by an internal hyperechoic layer representing translocated connective tissue of the hilum along with blood and lymphatic vessels, a central hypoechoic (usually large) region, which represents homogeneous fat cells with a relatively small number of vessels, can be often seen<sup>(2)</sup>. This area

should not be confused with a focal thickening of the parenchymal layer, which belongs to images suggestive of a metastatic focus and should be verified based on ultrasound guided fine needle aspiration biopsy (US-FNAB).

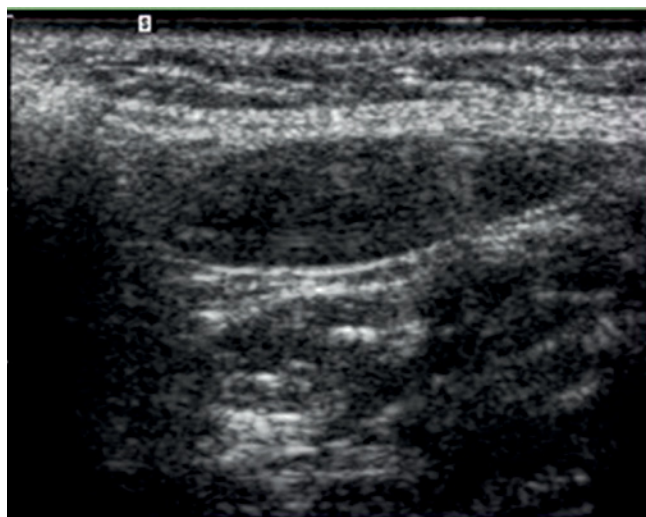
**Fig. 2.** A longitudinal hypoechoic focal lesion similar in shape to a lymph node is visible in the region of the mandibular body. No hilum is visible. The compression of the tissue with the probe should be reduced (by applying more gel if needed) and the lesion should be visualized in different planes, transverse plane in particular, to avoid misdiagnosis of the suspicious lymph node. This is a segment of the facial vein compressed between the poles of the probe.

which can make it difficult to move the US transducer and prevent its adhesion to skin, particularly in thin, cachectic or emaciated patients. Under these conditions, one of the jugular veins, e.g. the internal jugular vein or the facial vein, can be unconsciously compressed with the transducer poles, producing an image of an abnormal lymph node with no hilum (Fig. 2). If this happens, obviously no blood flow will be observed inside the structure. It may seem hypoechogenic due to artifacts in the superficial tissues, but even if it is anechoic, a pseudocyst can be suspected (see below). The mistake can be identified simply by reducing transducer compression on the tissues, and if the transducer no longer adheres to the skin, more ultrasound gel should be applied between the transducer and the skin, and the image should be tracked in the transverse plane.

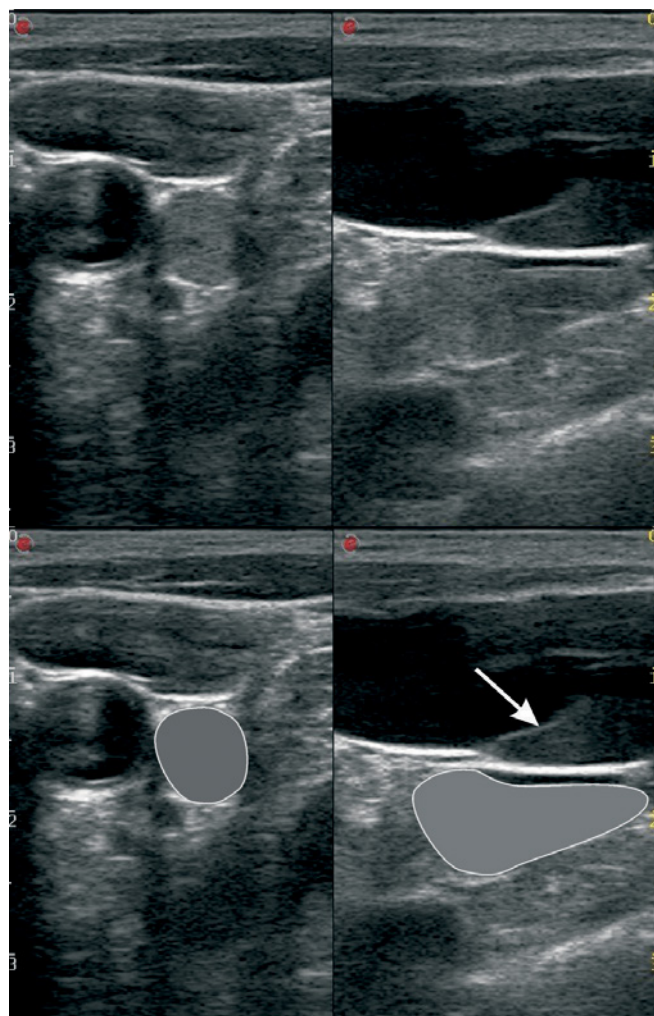
**Fig. 3.** A cross-sectional (on the left) and a longitudinal (on the right) ultrasound of the region at the left base of the neck. A longitudinal, hypoechoic focal lesion (marked in grey in the lower images), which can be confused with an abnormal lymph node or other solid lesion (e.g. an enlarged thyroid gland) is visualized laterally to the common carotid artery and below the internal jugular vein. This corresponds to the branch of the internal jugular vein with erythrocyte rouleaux (visible segmentally). Minor rouleaux can be also seen in the longitudinal view – in the internal jugular vein below the valve (arrow).

At the base of the neck, compression of the veins located in the region of the upper thoracic outlet can occur. This may lead to erythrocyte rouleau formation in the internal jugular vein or its branches, which results in a hypoechoic image of the inside of the vein, simulating solid tissue in an ultrasound image. The visualized segments of the internal jugular vein branch may, in this case, appear like a longitudinal hypoechoic or hyperechoic focal lesion with no visible internal blood flow, which can be confused with a pathological lymph node or other solid lesion, such as an enlarged parathyroid gland (Fig. 3). Different inhomogeneities or artifacts (e.g. reverberation) can suggest the presence of a hyperechoic hilum and further confirm the mistake. A change in the position of the head or an examination in a sitting position should restore normal, spontaneous blood flow in the vein and explain the mistake.

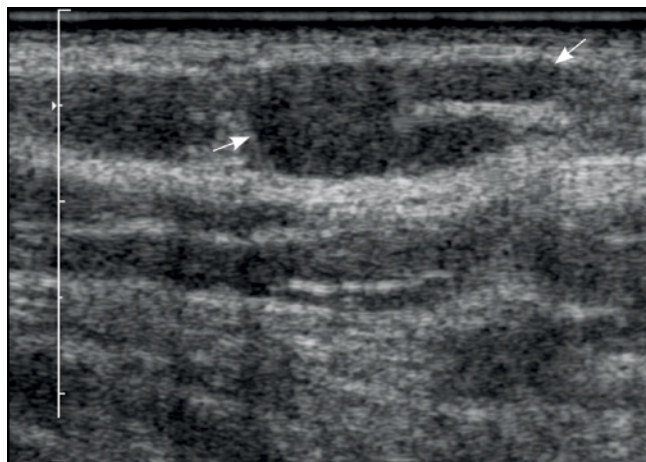
**Fig. 4.** An longitudinal lymph node (arrows) with a homogeneous parenchymal layer and a maintained, undisturbed linear hyperechoic hilum – an US image of a reactive lymph node. Histopathological examination of the resected lymph node revealed a lymphocytic lymphoma.

Lymph nodes in lymphomas may be indistinguishable from reactive lymph nodes in ultrasound, also with the application of color or power Doppler option (Fig. 4)<sup>(3,4)</sup>.

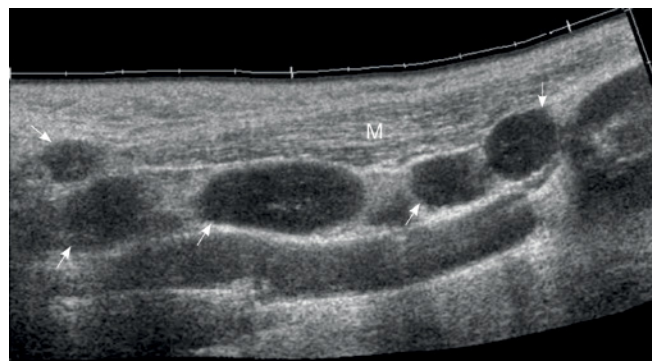
**Fig. 5.** Multiple enlarged lymph nodes (arrows) along the sternocleidomastoid muscle (M): oval, round and longitudinal, hypoechoic, with no clearly visible hilum. The ultrasound image is ambiguous – it could indicate lymphoma, however, metastases cannot be excluded. Final diagnosis: sarcoidosis.

Lymph nodes in granulomatous diseases, such as tuberculosis or sarcoidosis, can resemble metastatic lymph nodes (i.e. include calcifications, anechoic areas, lack the hilum, show heterogeneous structure) or lymphomas (i.e. present as hypoechoic, have no clear hilum) (Fig. 5)<sup>(6)</sup>. The differential diagnosis of these conditions is particularly problematic, especially in the world regions of their common coexistence. The optimal management is to first perform US-FNAB and, depending on the findings, perform another biopsy or a total resection of the lymph node (following an exclusion of metastatic lesions) and a chest X-ray. Visualization of oval, heterogeneous focal lesions, possibly with anechoic areas and calcifications, within the neck in a patient with a primary neoplastic focus indicates high probability of metastases. In the case of accidental detection of a lesion or lesions with the above characteristics, other primary tumors that can occur in this region as well as non-neoplastic lesions and primary lymph node diseases should be considered in the differential diagnosis. Preferably, US-FNAB should be performed, together with further diagnosis aimed to search for the primary tumor.

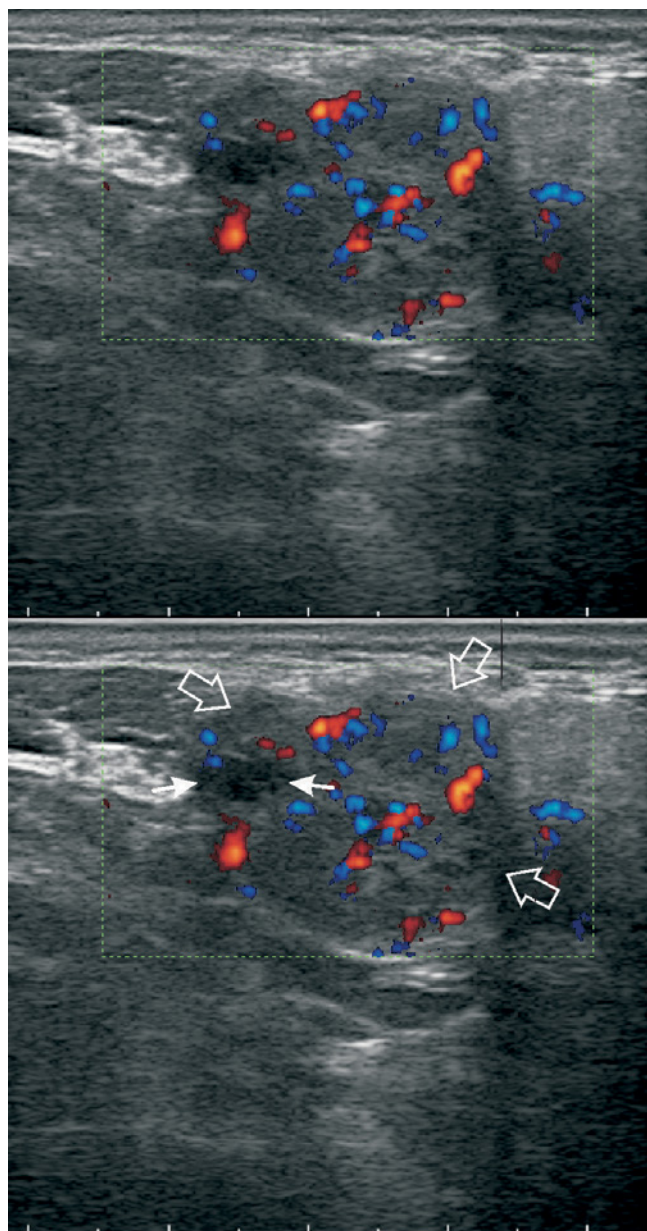
**Fig. 6.** A suppurative reactive lymph node. A cross-sectional view of a lymph node (thick arrows) located near the mandible angle. Increased blood flow and anechoic area with no blood flow (thin arrows) can be seen inside the lymph node. However, if no acute clinical symptoms are present and no laboratory findings indicating acute infection are reported for this lymph node image, US-guided FNAB should be performed – with no correlation with the clinical picture, a metastatic lymph node may have the same appearance.

Inflamed lymph nodes can undergo suppuration. This results in the occurrence of irregular anechoic and/or hypoechoic areas with no features of blood flow within these lymph nodes (Fig. 6). A similar picture can be observed in necrosis and/or bleeding to metastatic lymph nodes. Clinical data and laboratory findings are therefore of key importance in the differential diagnosis. In exceptional cases, such as immunodeficiency, these data can be misleading. Suppurative lymph nodes should not be overinterpreted and considered metastatic. A follow-up ultrasound after treatment should be recommended instead, but not later than after a month. On the other hand, the diagnosis of metastasis should not be delayed by suggesting lymph node suppuration. In the case of doubts or evident metastases, US guided FNAB should be performed immediately.

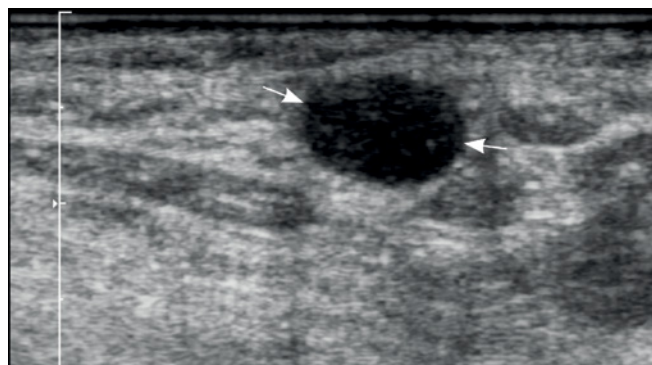
**Fig. 7.** An oval, well-delineated focal lesion (arrows) with acoustic enhancement behind the posterior outline – a grey-scale ultrasound image of a simple cyst. Lymphocytic lymphoma (after histopathological examination of the totally resected lymph node).

Lymph nodes can mimic a simple cyst in grey-scale ultrasound, particularly in lymphomas and some types of metastases (e.g. in poorly differentiated cancers, melanoma) (Figs. 7 and 8)<sup>(4)</sup>.

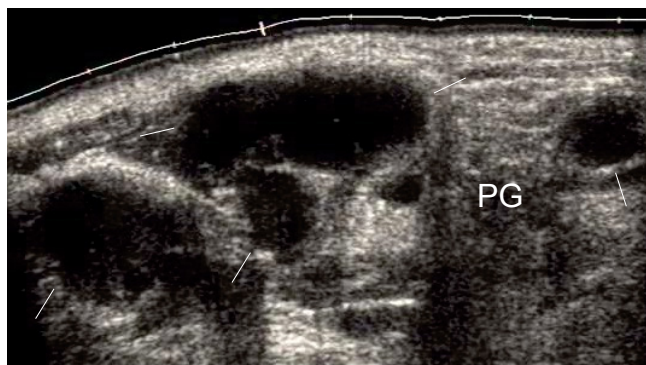
**Fig. 8.** Multiple oval and polycyclic, anechoic or nearly anechoic focal lesions (arrows) in the parotid gland (PG). US-FNAB-based diagnosis: poorly differentiated cancer.

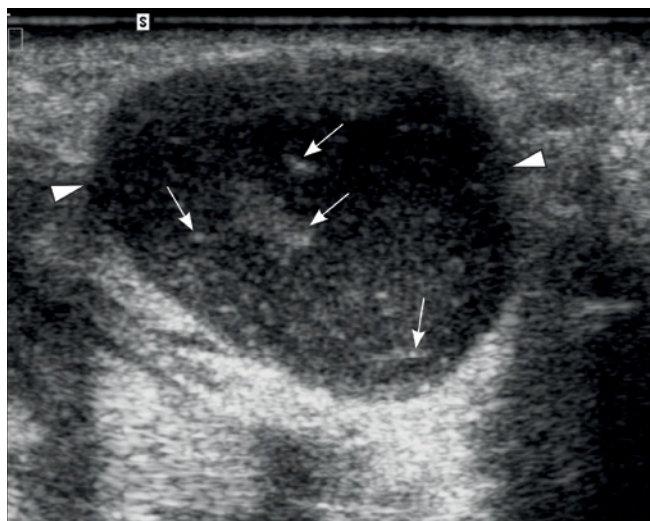
**Fig. 9.** An oval, well-delineated, nearly anechoic focal lesion in the submental-submandibular region (arrowheads) with acoustic enhancement behind the posterior outline. Inside the lesion, delicate hyperechoic structures can be seen: linear, point or diffuse (examples marked with arrows). Non-Hodgkin lymphoma (histopathological diagnosis).

Lymph nodes with a misleading US picture of a simple cyst can be found not only in a typical location within the neck (e.g. in the submandibular area, along the borders of or under the sternocleidomastoid muscle, along the large neck vessels), but also in the parotid gland parenchyma. The frequency of a pseudocystic appearance of lymphomas decreases with increasing ultrasound resolution. Grey-scale ultrasound using high-frequency probes usually reveals a delicate hyperechoic network or fine punctate echoes

(Fig. 9)<sup>(4,7)</sup>. A hyperechoic hilum can be absent or very narrow in lymphomas.

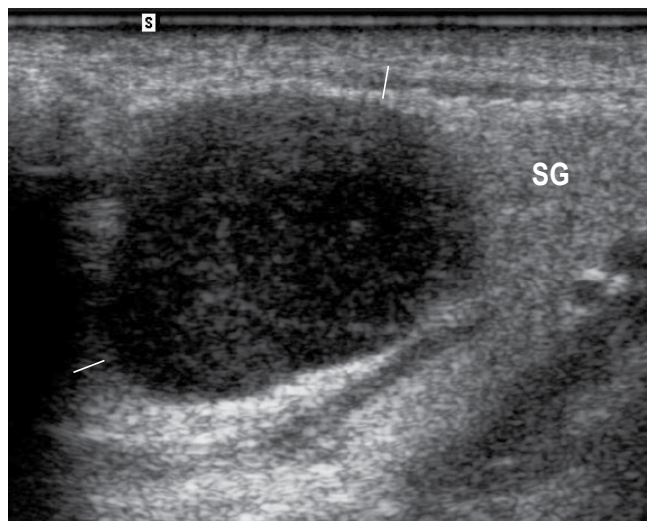
**Fig. 10.** An oval, well-delineated, nearly anechoic focal lesion (arrows) with acoustic enhancement behind the posterior outline, compressing the submandibular gland (SG) parenchyma – the grey-scale image may indicate a cyst with dense contents. Non-Hodgkin lymphoma (histopathological diagnosis).

Reactive lymph nodes can also mimic a simple cyst in grey-scale ultrasound, similarly as lymph nodes with total central necrosis and cystic metastases, e.g. of papillary thyroid cancer, when the entire interior of the metastasis is filled with fluid, and histopathological evaluation shows that only the external layer of the cystic lining is comprised of neoplastic cells. Particular problems arise when abnormal lymph nodes are single (Fig. 10). Although this is rare, it can occur in both lymphomas and metastases.
